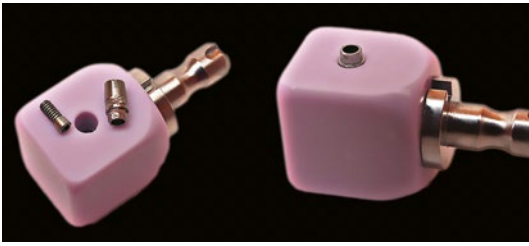
21 | Pre-drilled e.max block.

Using digital design software, the work area was reduced to the immediate region of the implant (Fig. 18), while both arches were put into the virtual articulator to check occlusion (Figs. 19a and b). The restorative design was performed on the virtual implant (Figs. 20a and b). The software is very intuitive and automatically recognizes the type of implant solution used. The restoration was then fabricated from an IPS e.max bloc (Ivoclar Vivadent, Schaan, Liechtenstein) and the final touches were made (Figs. 21 to 24).

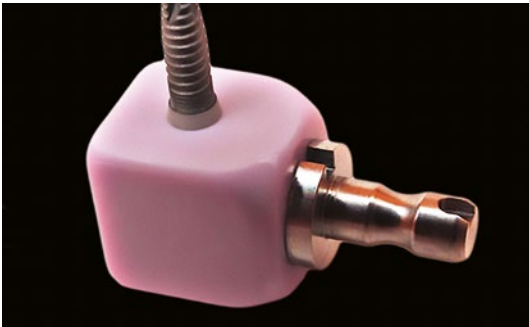
22 | Precision fit with the Z1 implant.

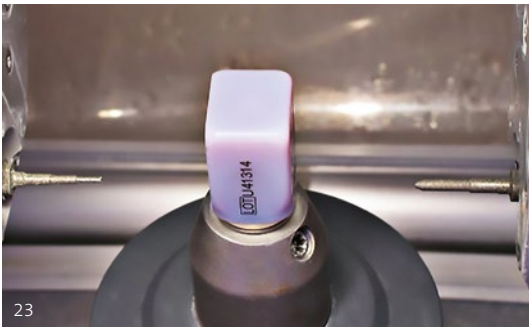
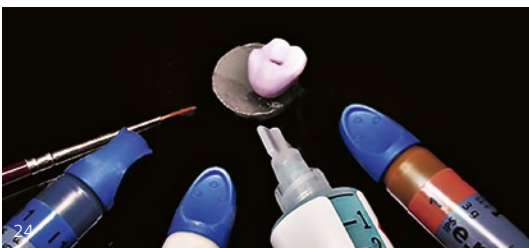
23 | The crown is milled ... 24 | ... and finished.

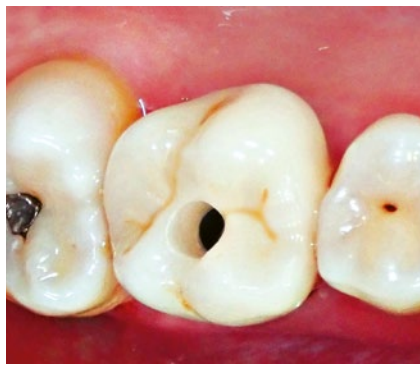
25 | Screw-retained crown in the patient's mouth.

The final restoration was screwed into place with a torque of 30 Ncm (Fig. 25). Composite was placed to fill the screw access hole and complete the occlusal surface of the crown (Fig. 26). Figure 27 shows the post-treatment radiograph, Figures 28 to 30 demonstrate papilla formation and creeping attachment along the emergence profile after six months of crown placement.

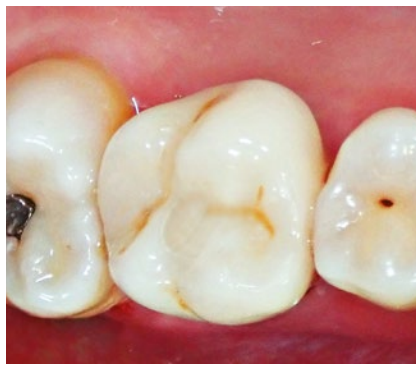
26 | The screw-hole is filled with composite.

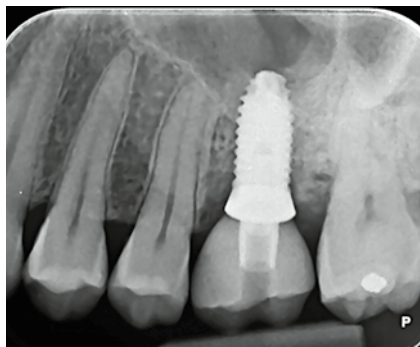
27 | Post-treatment radiograph.

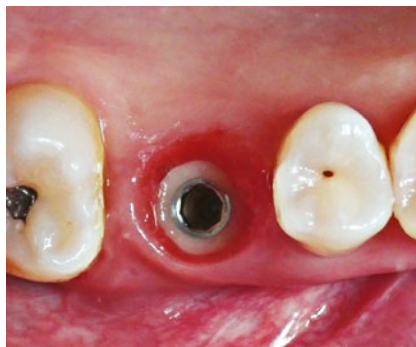
28 | Creeping attachment of gingiva after six months of crown placement.

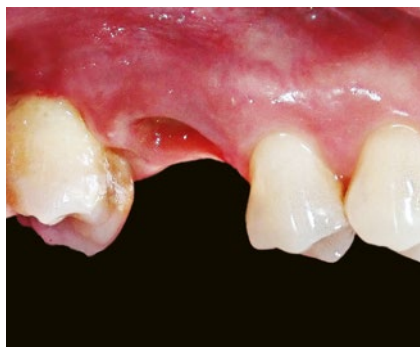
29 | Papilla repositioning ...

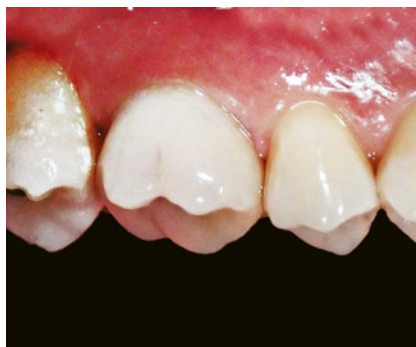
30 | ... and final restoration after six months of crown placement.
